**Flood Control Project Maintenance
Levee Inspections
LMA District Cover Sheet
Spring 2010 Levee Inspection Results**

California Department of Fish and Game Shea Levee

Levee Inspection Report By Mile - Spring 2010

Waterway						Bank	Unit Miles	Inspection Start/End	Inspector
Unit No. 01 Sacramento River						Left	0.30	05/07/2010 05/07/2010	Bob Duffey

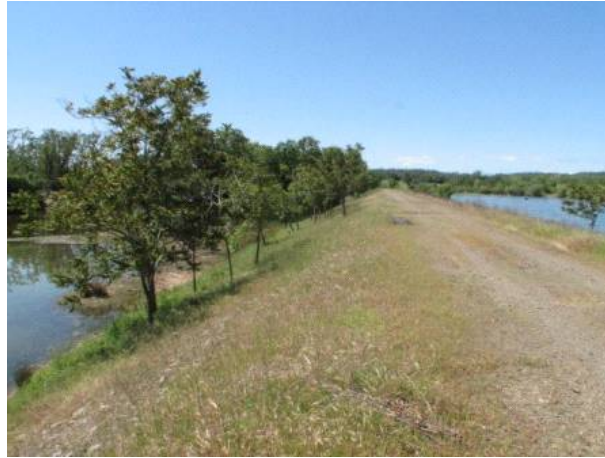
rduffey_s_20100628_095.jpg

LMR No	Levee Mile		Category	Item	Location *	Rating **	Action/Comment	GPS Latitude/Longitude		Issue No.
	Start	End						Start	End	Photo
1	0.00	0.30	Earthen Levee	Vegetation	LS	A	Control annual grass and weeds on the levee slopes and easements.	°	°	3
								°	°	Y

Levee Mile Report Line	1
Start Levee Mile	0.00
End Levee Mile	0.30
Location	Land Side
Category	Earthen Levee
Item	Vegetation

View of the trim up trees and native grasses along landside slope of the levee.
